**Investigating the Mechanism of Transgranular Stress Corrosion
Cracking in Near-Neutral pH Environments on Buried Fuel
Transmission Pipelines**

A Dissertation
Presented to
The Academic Faculty

Georgia Institute of Technology
December 2007

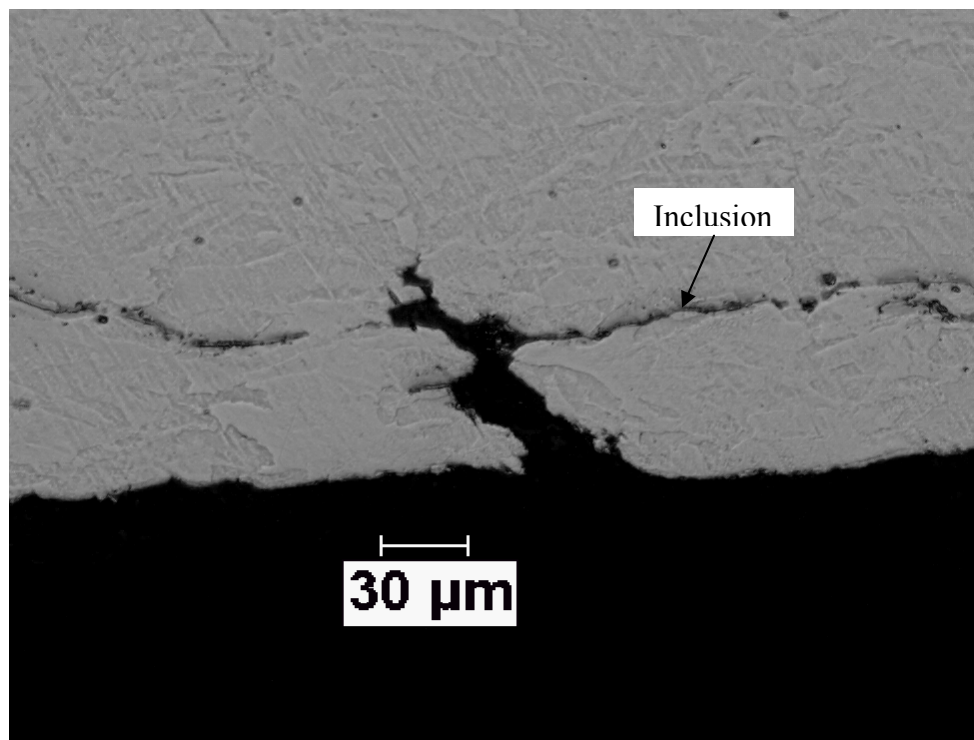
Figure 81 - Crack morphology of pipeline steel strained in NS4 solution with 5% CO₂ at room temperature and OCP

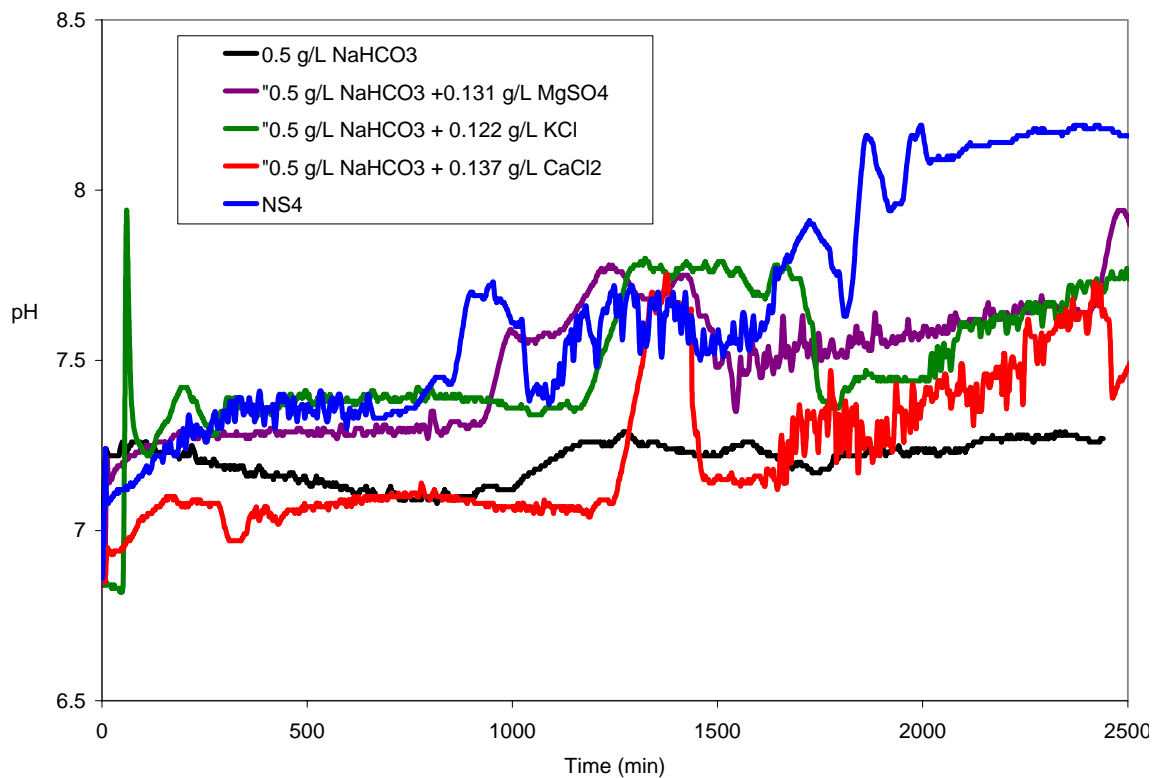
Figure 82 - Surface pH measurement with time for solution components of TGSCC environments

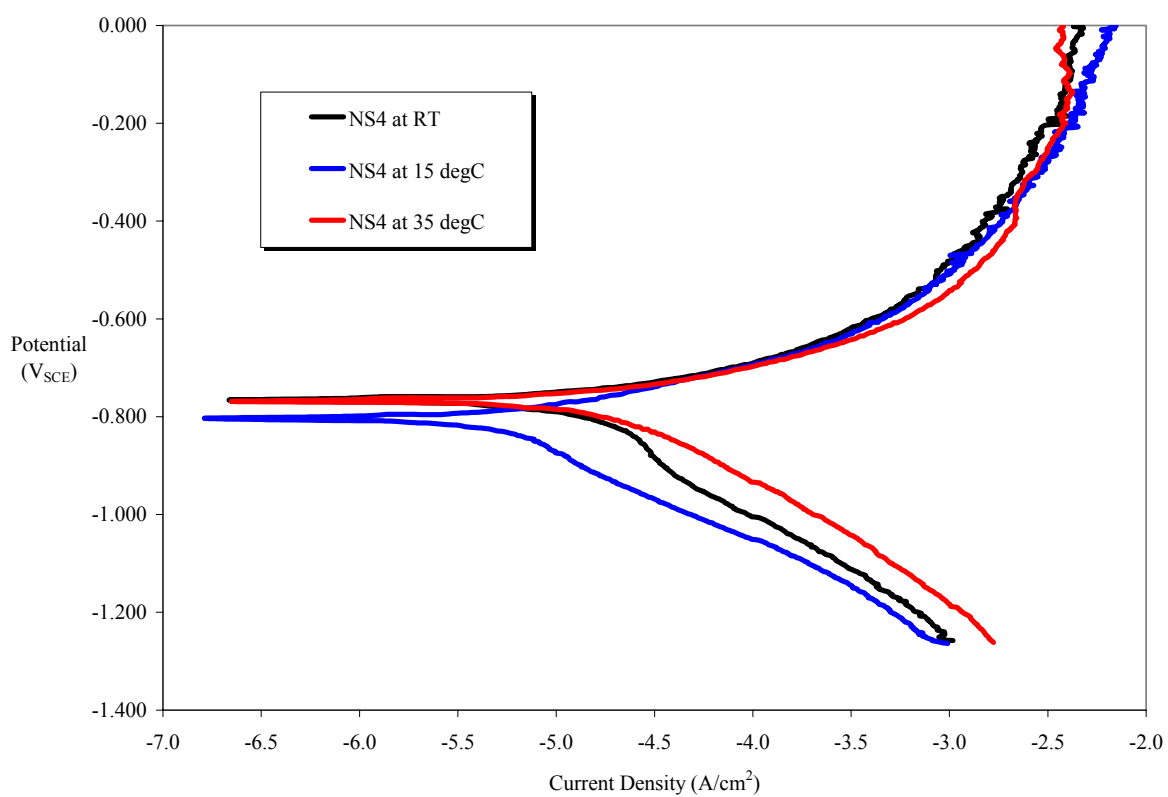
Figure 83 - Potentiodynamic results for NS4 solutions with 5% CO₂ at different temperatures

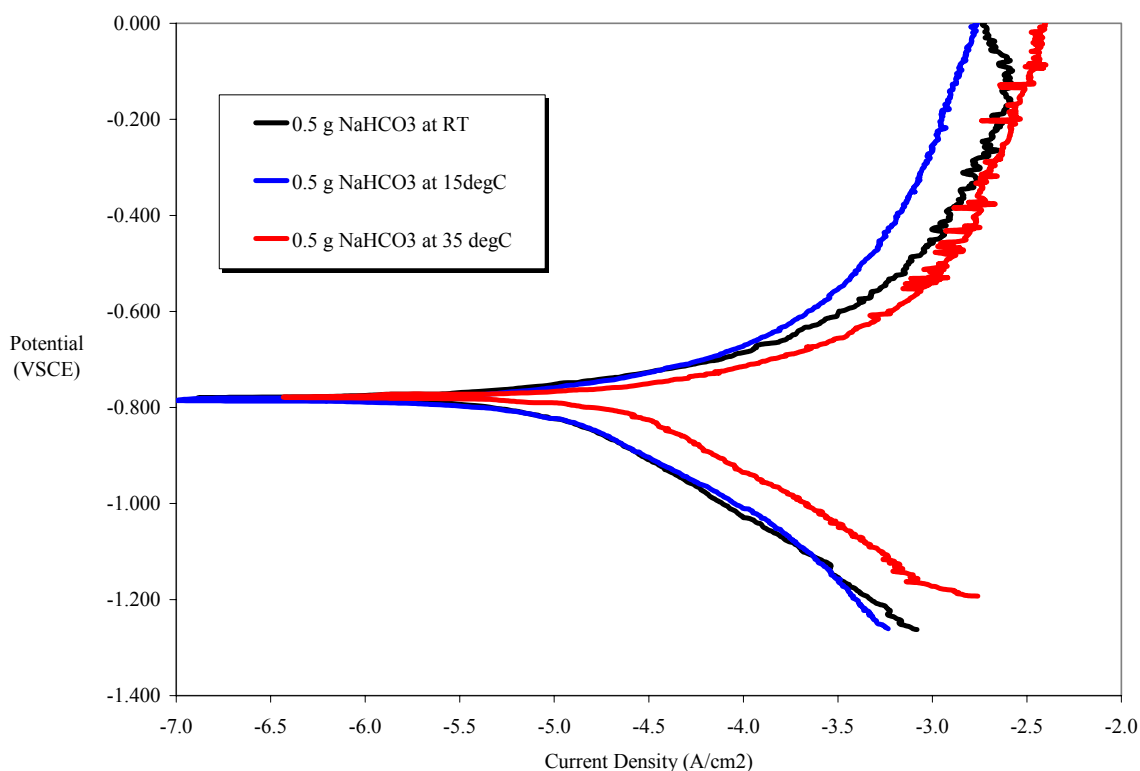
Figure 84 -Potentiodynamic results for simple bicarbonate solutions with 5% CO₂ at different

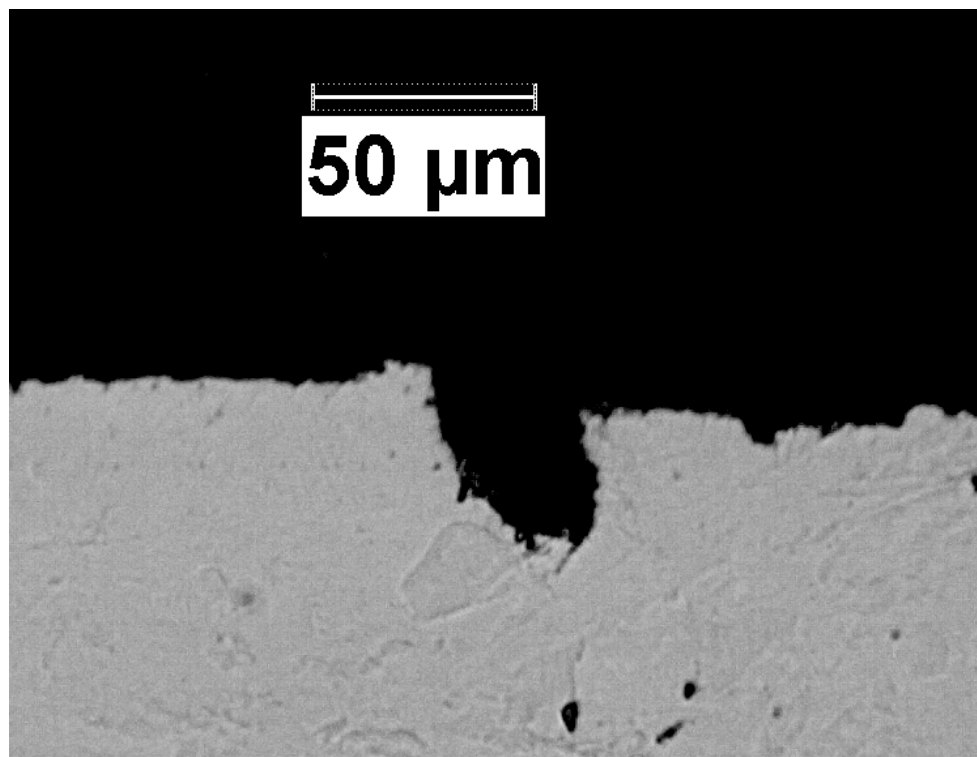
Figure 85 - Pit formed on X-65 pipeline steel exposed to shift between IGSCC and TGSCC environments. Note the formation of what appears to be a crack tip at the bottom of the pit.

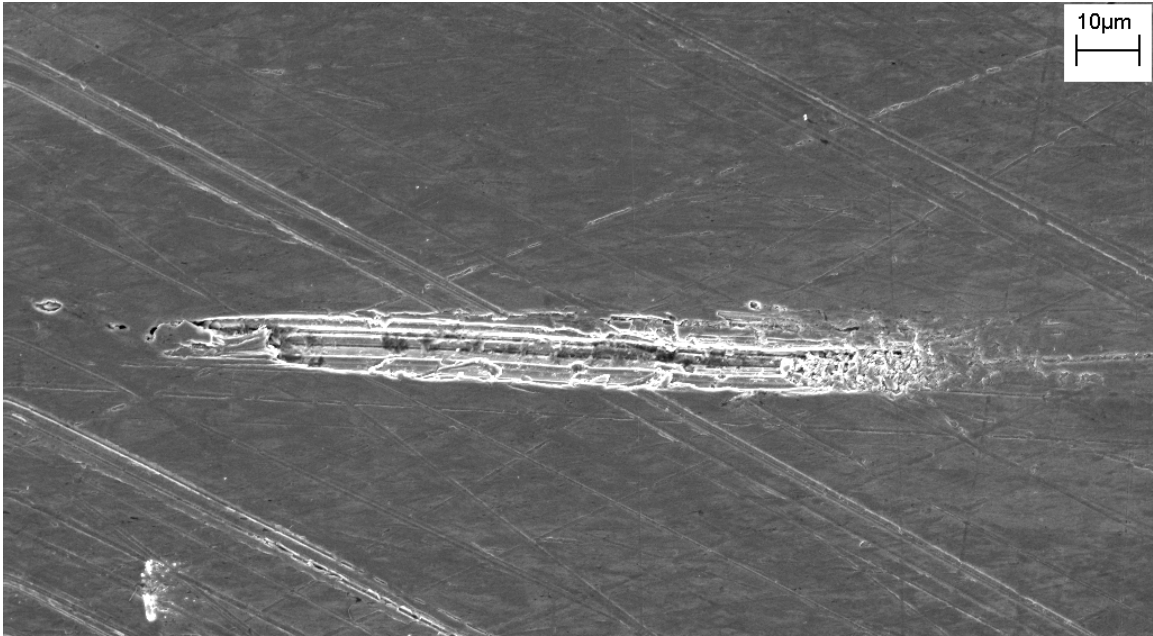
Figure 86 - Rupture of magnetite film formed when X-65 pipeline sample is exposed to 1N NaHCO₃ with 1N Na₂CO₃ at 70°C and -650 mV and held at 85% yield strength for 5 days

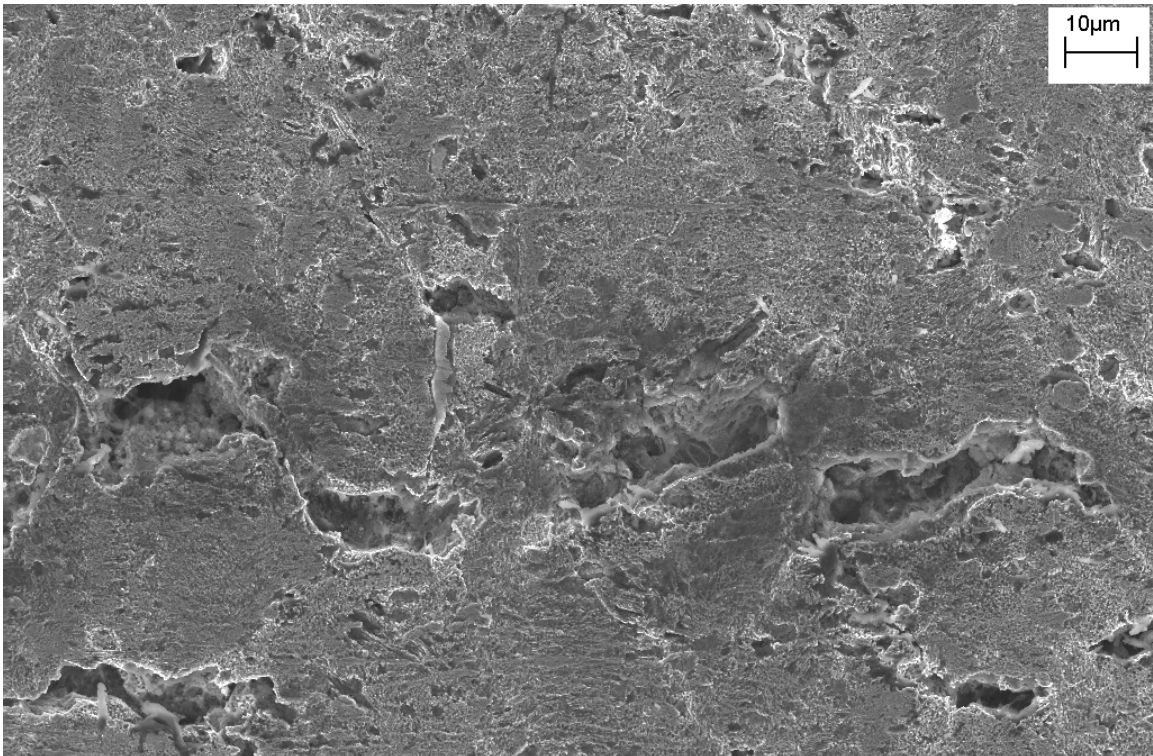
Figure 87 - General sample surface morphology of sample once environment has been shifted from IGSCC conditions to TGSCC conditions

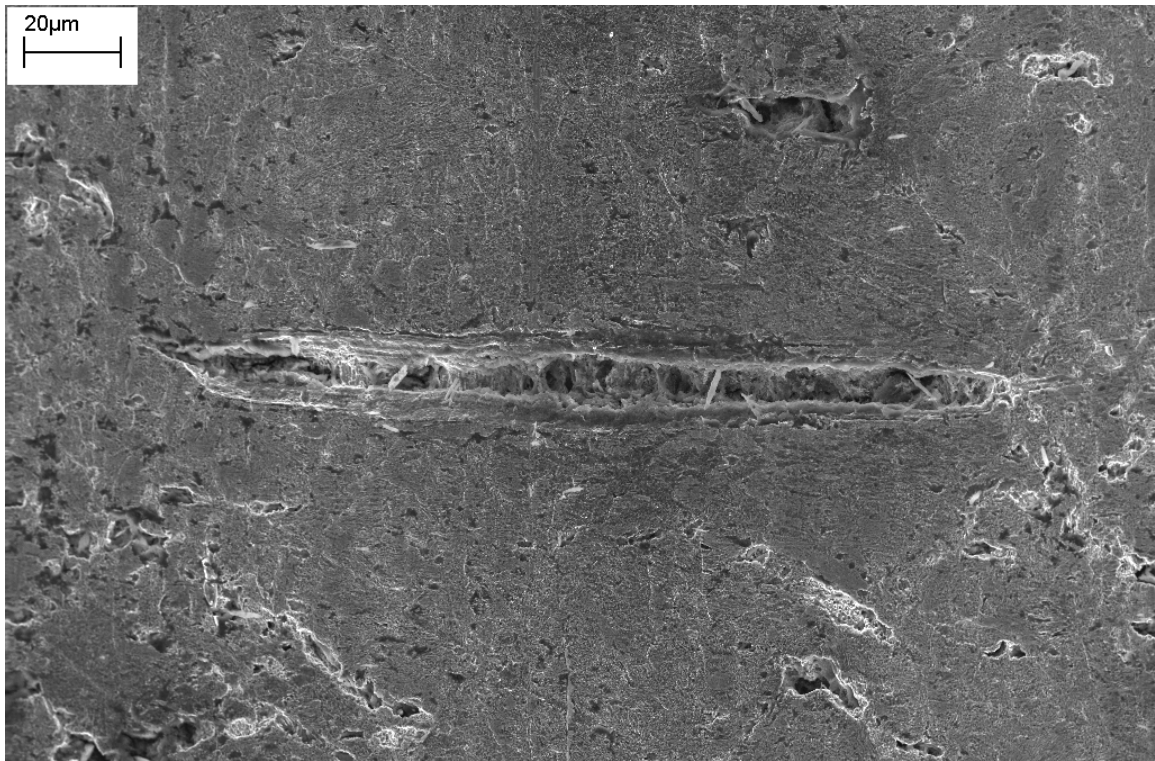
Figure 88 - Development of previous film rupture in TGSCC environment

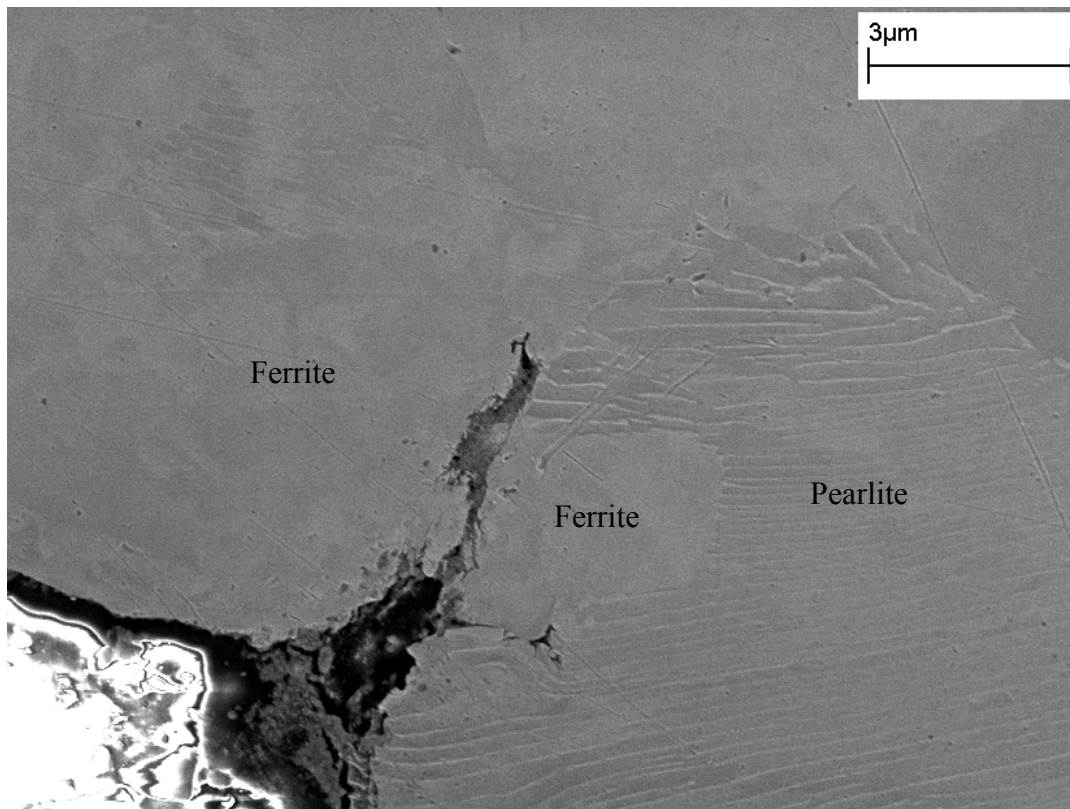
Figure 91 - Crack formed on pipeline sample exposed to shift between IGSCC and TGSCC environments. The crack initially is intergranular, progressing between pearlite and ferrite grains. Crack path then becomes to be transgranular as it cuts through ferrite grain.

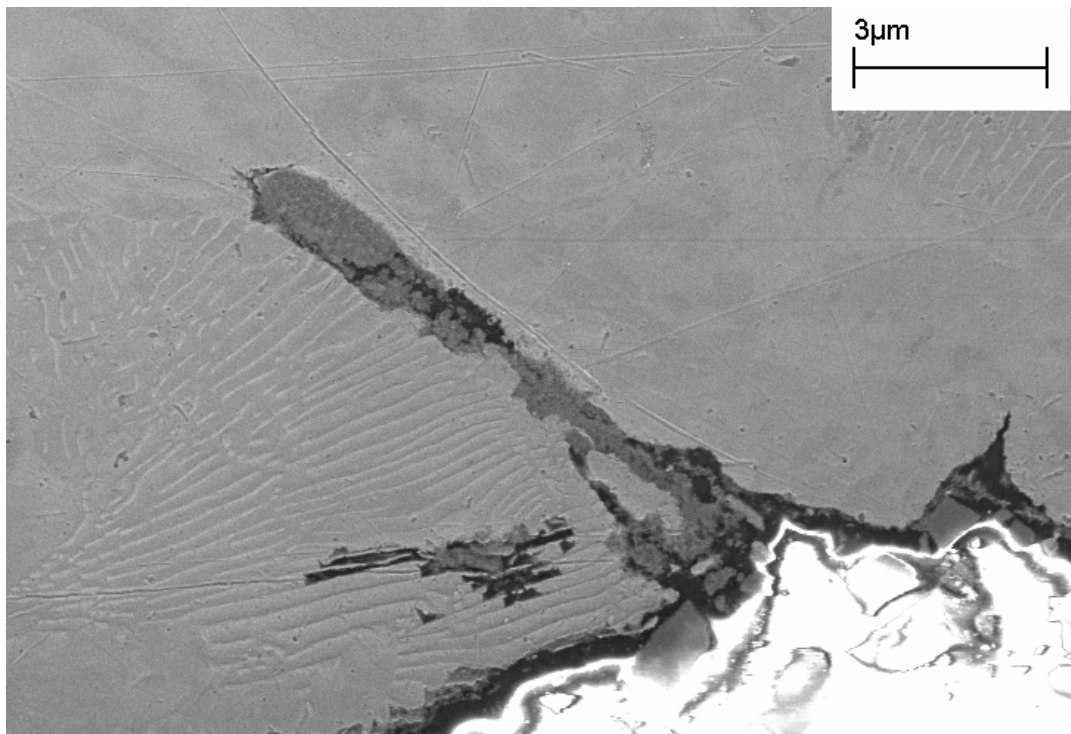
Figure 92 - Intergranular Stress Corrosion Crack formed on slow strain rate sample subjected to shifting environmental conditions

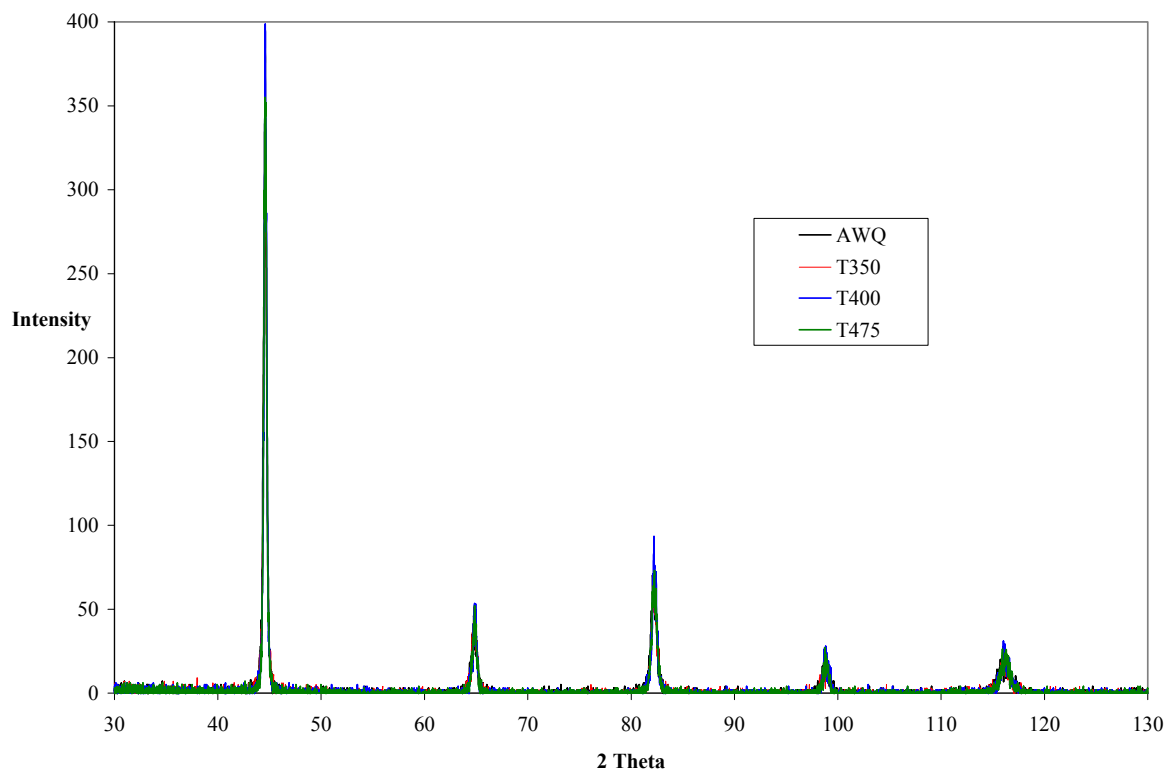
Figure 93 - Comparison of spectra for all quenched pipeline microstructures

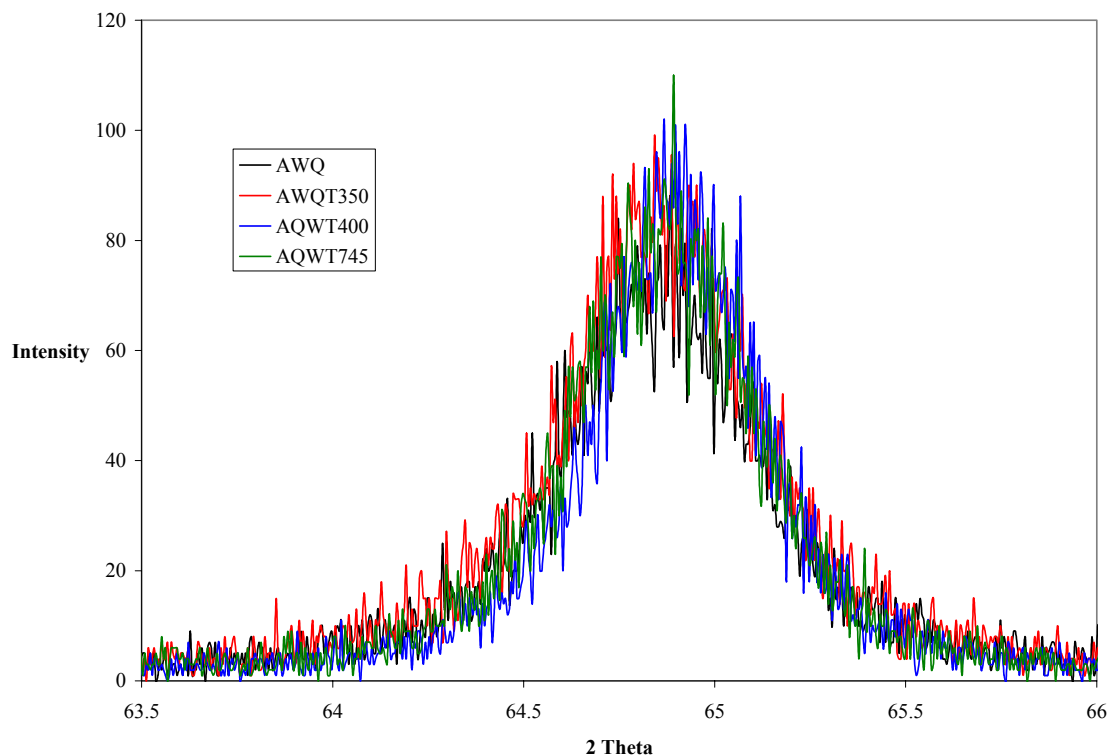
Figure 94 - Spectra from 64 2Theta peak for water quenched pipeline microstructure

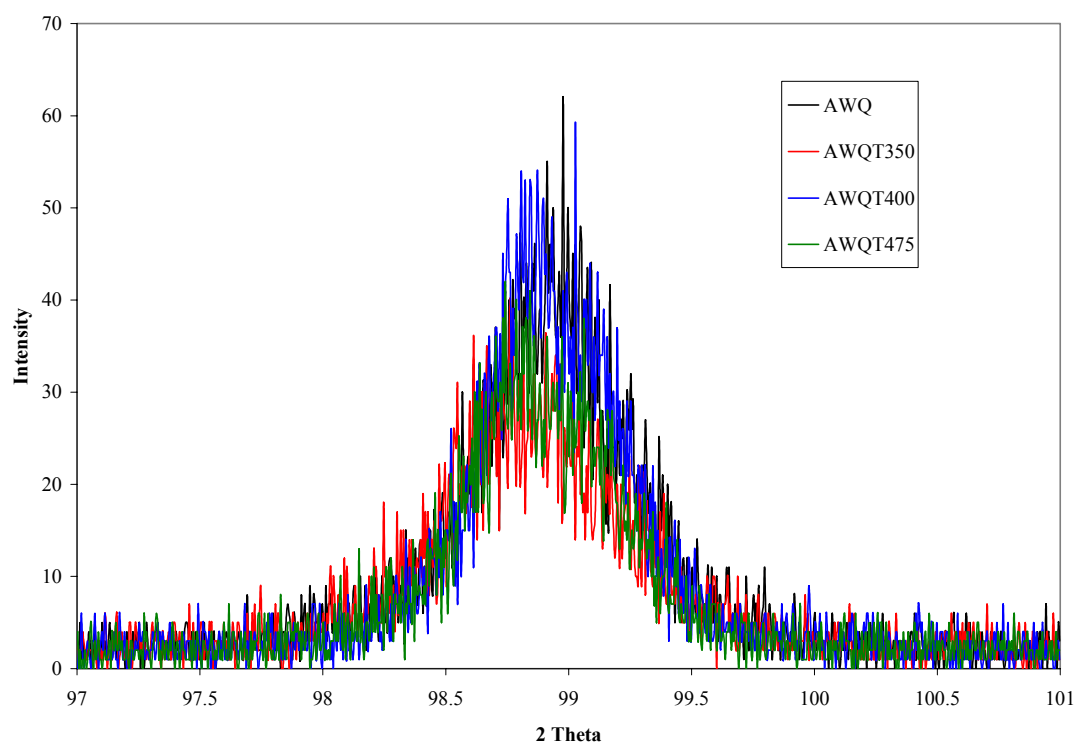
Figure 95 -Spectra from 98 2Theta peak for water quenched pipeline microstructure

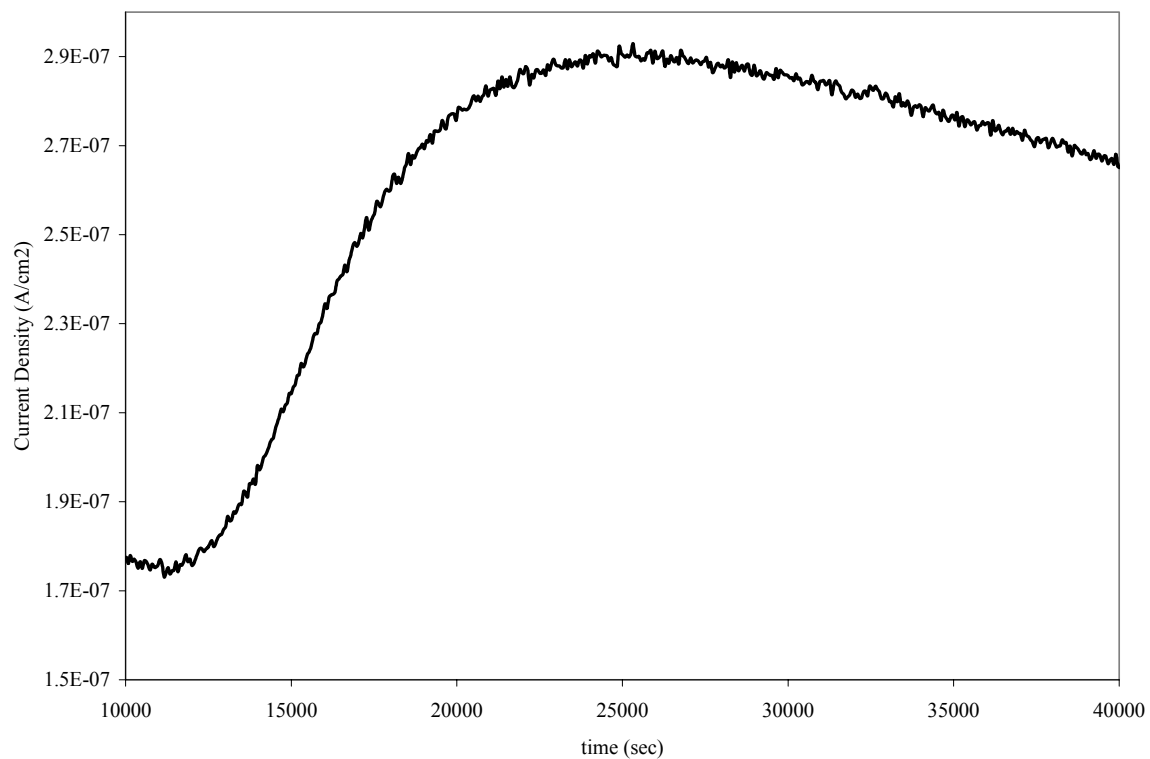
Figure 99 – Representative hydrogen permeation curve for Tempered 350°C pipeline steel microstructure

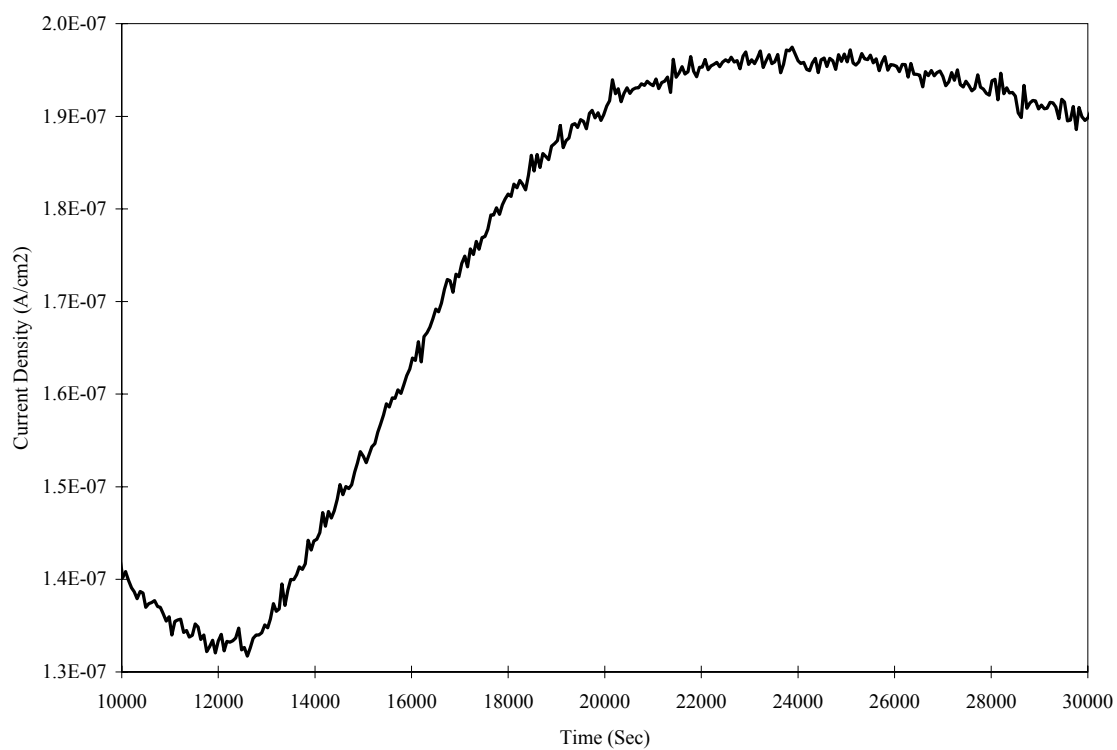
Figure 100 - Representative hydrogen permeation curve for Tempered 400°C pipeline steel microstructure

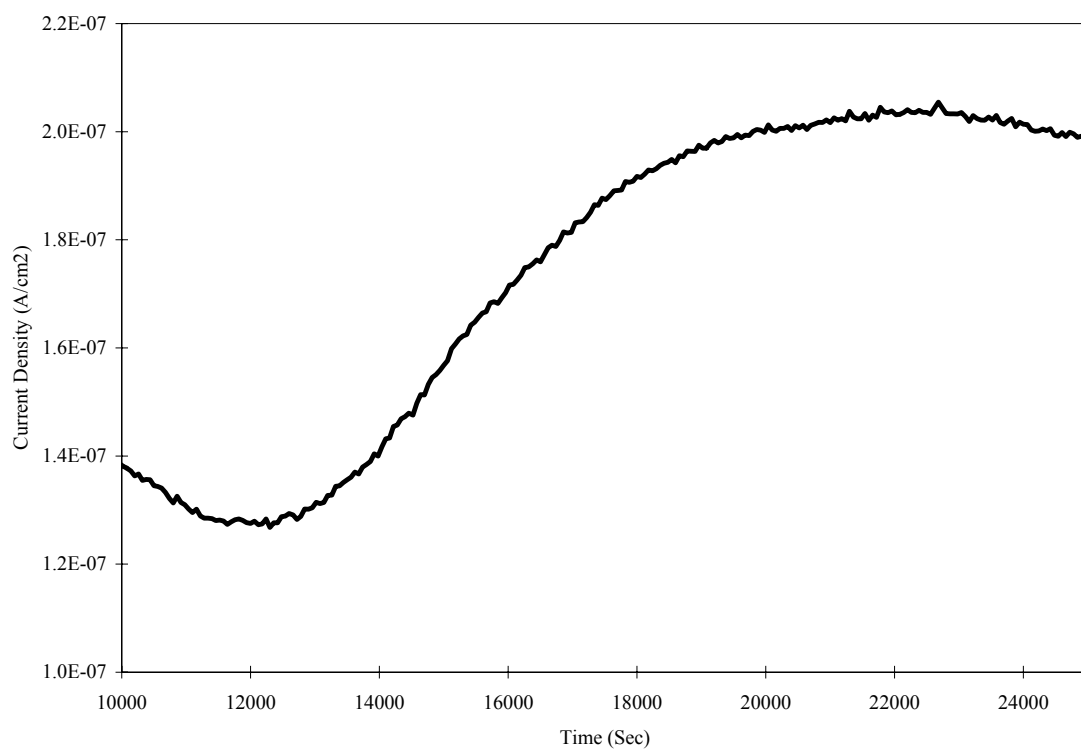
Figure 101 - Representative permeation curve for Temper 475°C pipeline steel microstructure

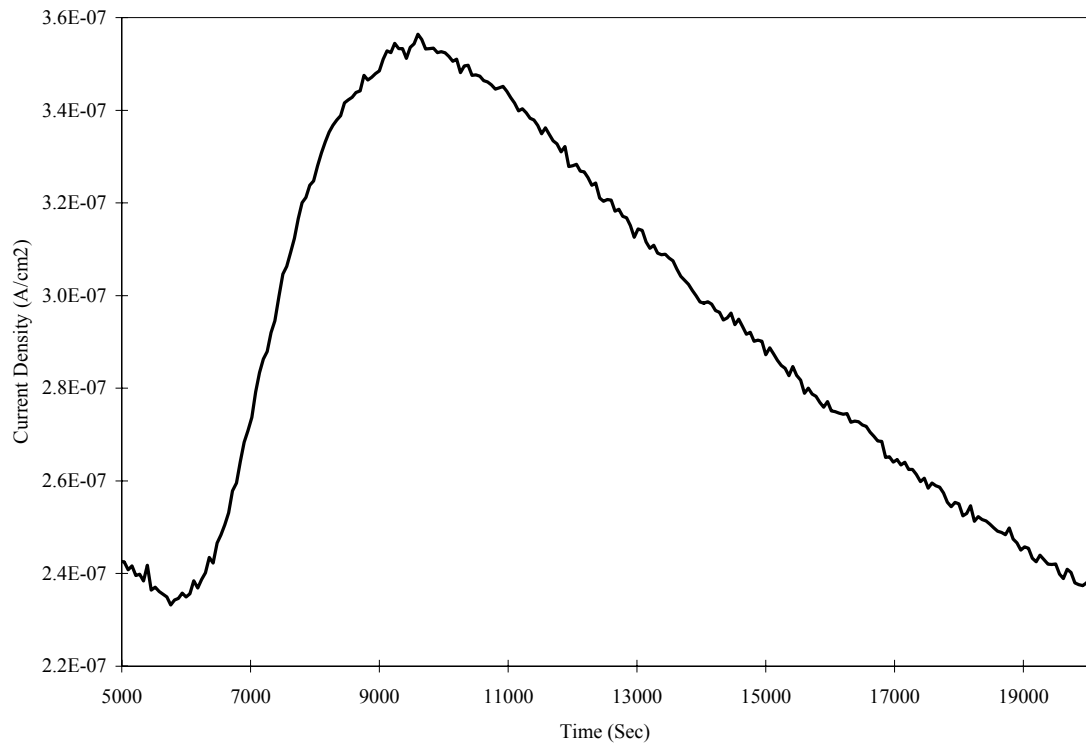
Figure 102 - Representative permeation curve for Temper 650°C for one hour pipeline steel microstructure

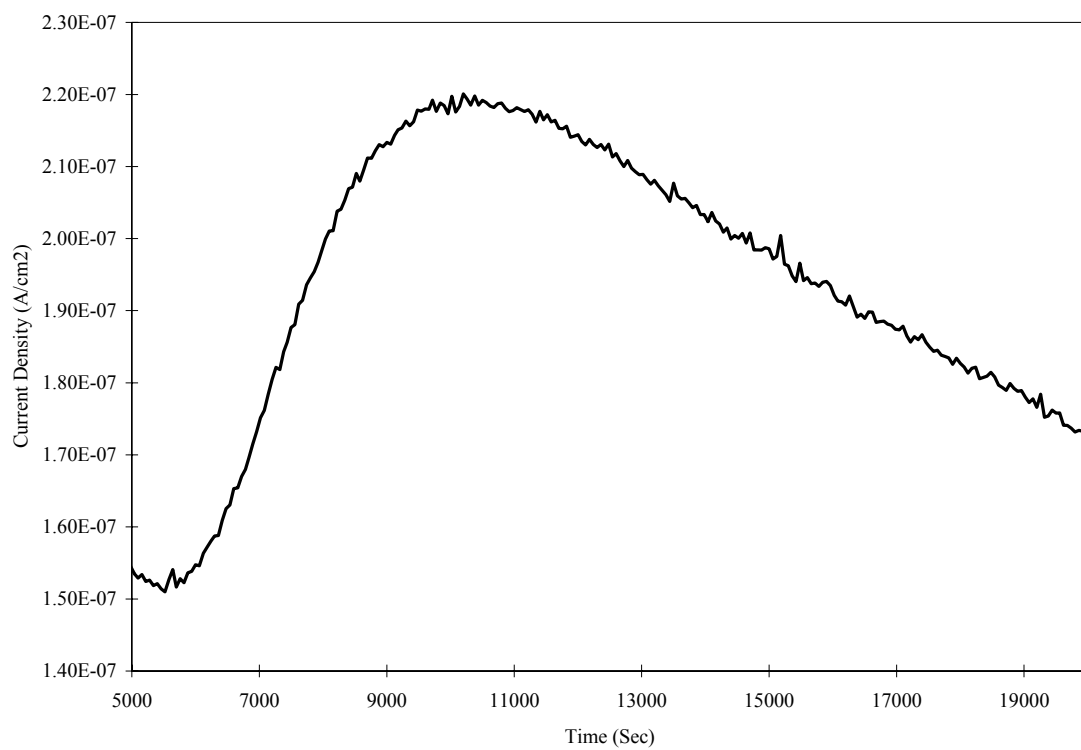
Figure 103 - Representative permeation curve for Temper 650°C for one day pipeline steel microstructure

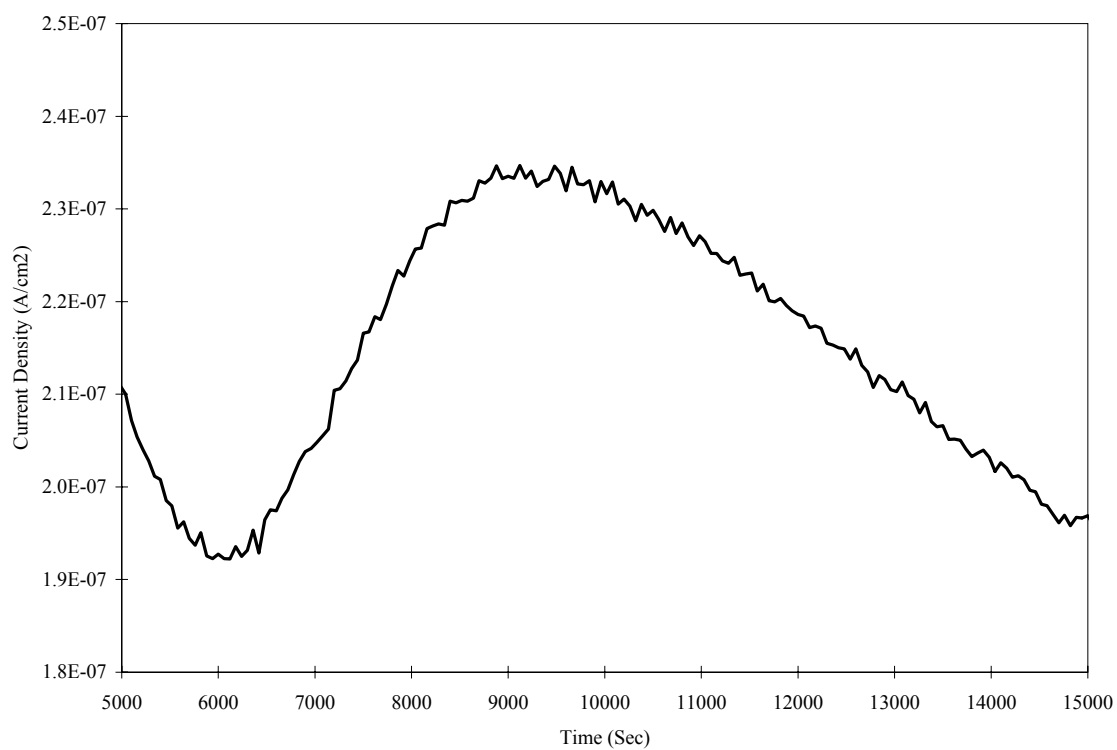
Figure 104 - Representative permeation curve for Temper 650oC for one week pipeline steel microstructure
